12
TECHNICAL REPORT M-312
March 1982

INVESTIGATION OF MATERIALS FOR
WATERPROOFING LEAKY CORRUGATED GALVANIZED
STEEL-ARCH MAGAZINES FROM THE INSIDE

by
Stanley M. Kanarowski

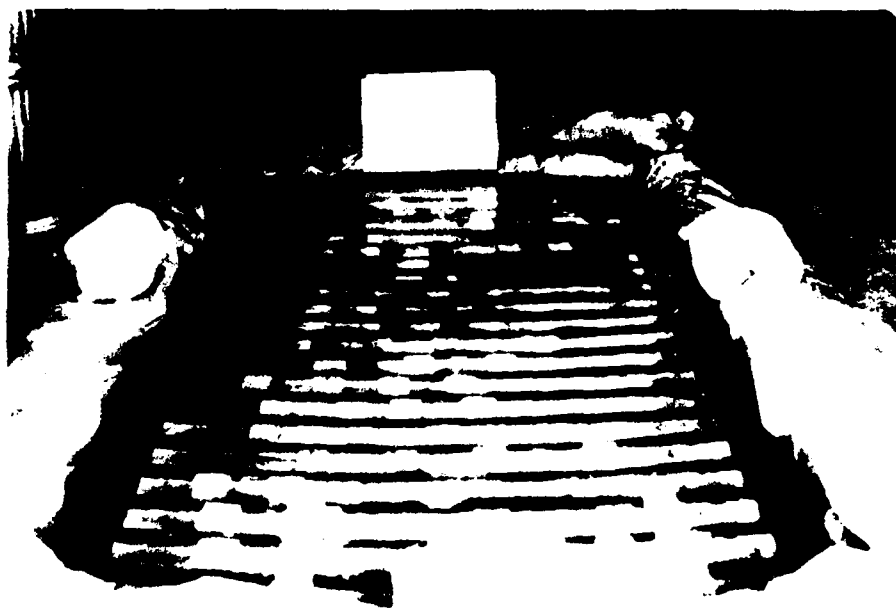
Figure 4. Corrugated galvanized steel panel with sealant specimens immersed in water.

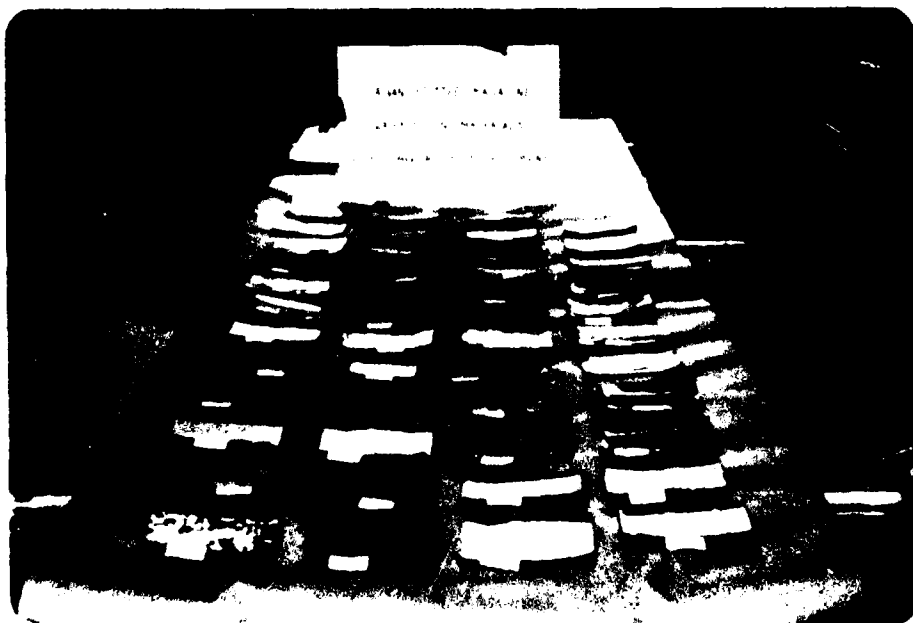
Figure 10. Sealant-butyl gasket adhesion compatibility specimens.

In some cases the material used for sealing the leak may touch the butyl gasket; thus, the sealant's adhesion compatibility with the gasket should be known. Figure 10 shows the specimens used in the visual and hand pull tests for determining the adhesion compatibility between the sealant and the butyl gasket.

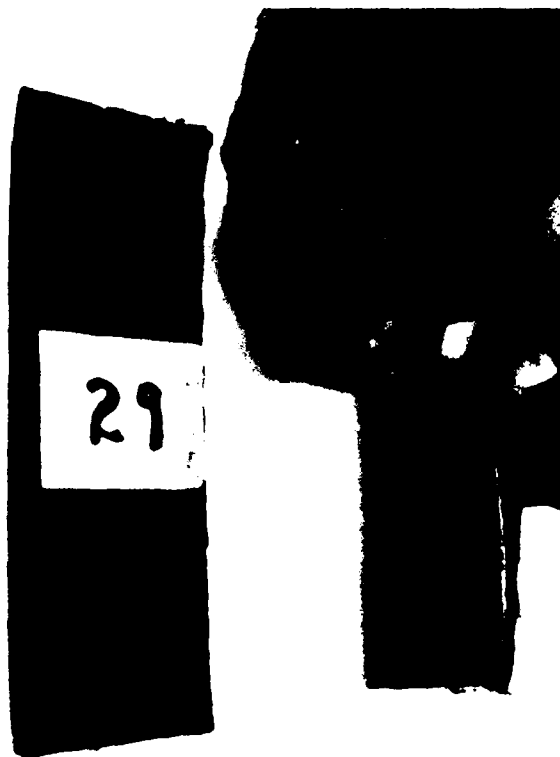
Figure 11. Sealants with good butyl gasket adhesion compatibility.

This test was conducted by applying the sealant being evaluated to 6-in (152-mm) lengths of 4-1/4-in. (108-mm)-wide gasket. After cure, the sample was cut in half lengthwise, and one specimen was immersed in water for 1 week at room temperature. Specimens were flexed and bent 180 degrees; adhesion, cracking, and color change were noted. Test results are listed in Table 4. Out of 46 sealant specimens in this test, there were 20 with good adhesion and no cracks, eight with bad adhesion, and 18 that were loose at the edge, had cracks, or were soft and tacky. The immersed specimens (1 week) were generally unaffected by the water, but were discolored slightly or looked a bit dirtier. Figures 11 and 12 show good and poor sealant/butyl-gasket adhesion compatibility.

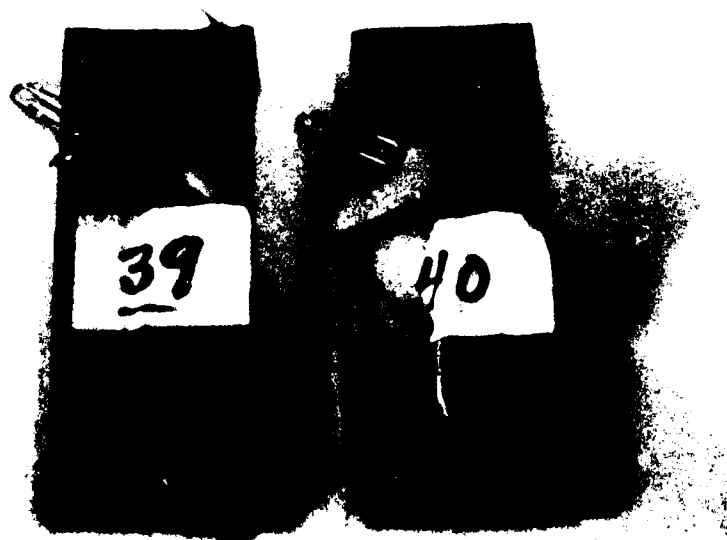
Figure 12. Sealants with poor butyl gasket adhesion compatibility.
